HOME INSPECTION REPORT

135 Highway 76, White House, TN 37188

Thursday, February 23, 2017

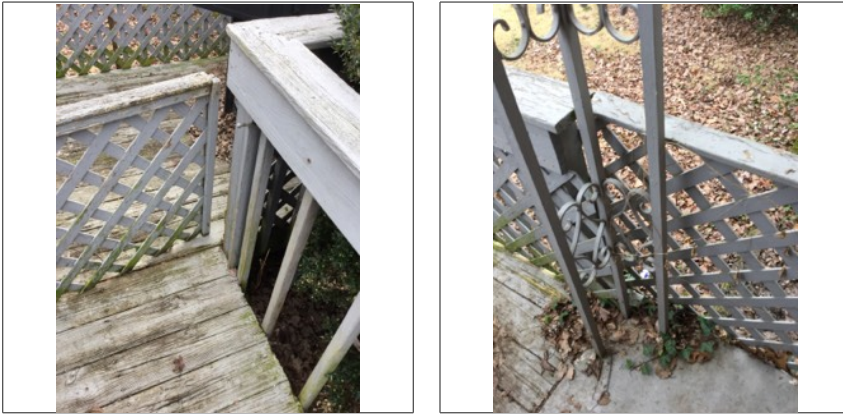
- None Not Visible
Condition Satisfactory Marginal Poor Railing/Balusters recommended
Support Pier Concrete Wood Other: Metal
Floor Satisfactory Marginal Poor Safety Hazard
Comments Gate on ramp to front porch needs repair. The railing at the concrete porch is not very secure

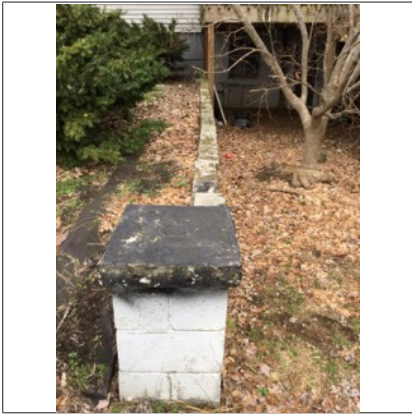
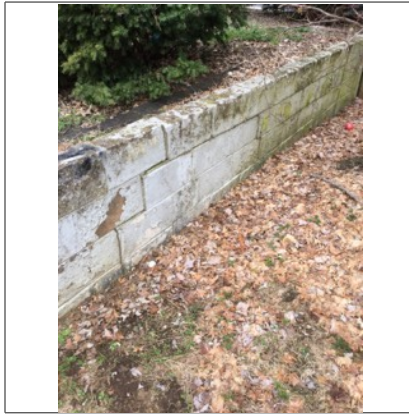
- None
Material Brick Concrete Concrete block Railroad ties Timbers Other: .
Condition Satisfactory Marginal Poor Safety Hazard Leaning/cracked/bowed
 Drainage holes recommended
Comments

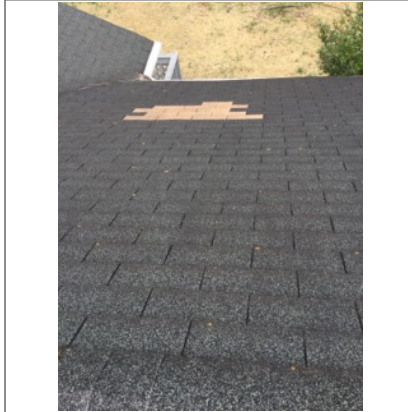
Two different shingles

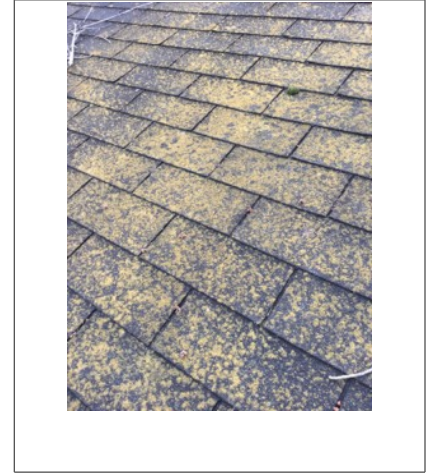
Previous repair. Not sure why they didn't use grey shingles

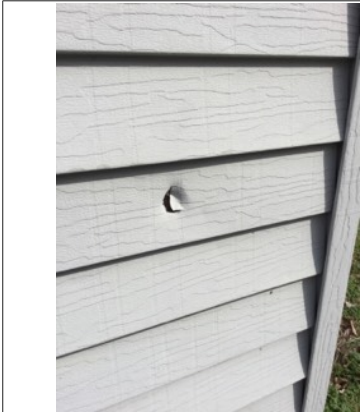
Comments Siding only has a few spots to repair. Caulk any holes. Touch up a few paint spots

Seal holes

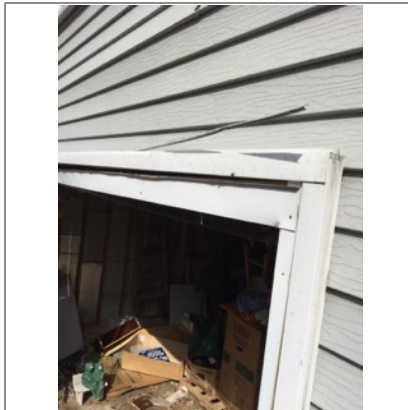
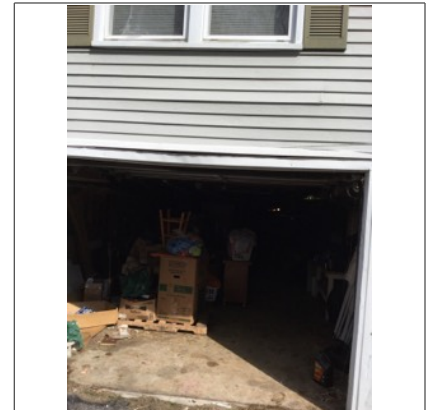
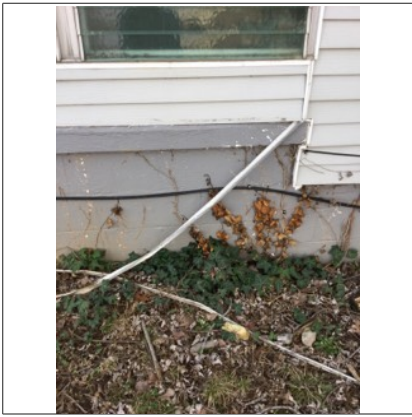
Comments There just a few areas of needed trim repair. See photos

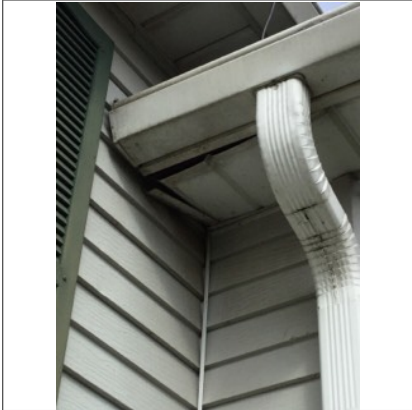
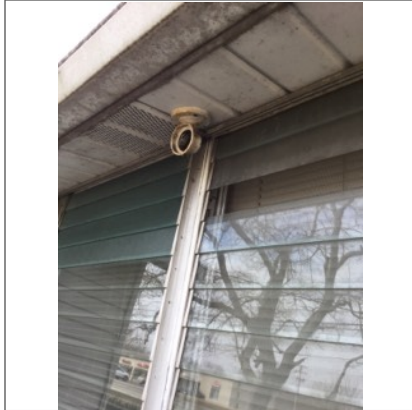
Material None Wood Fiberboard Aluminum/Steel Vinyl Stucco Recommend repair/painting
 Damaged wood Other: .
Condition Satisfactory Marginal Poor
Comments One corner on the east side needs repair. Light missing
Photos

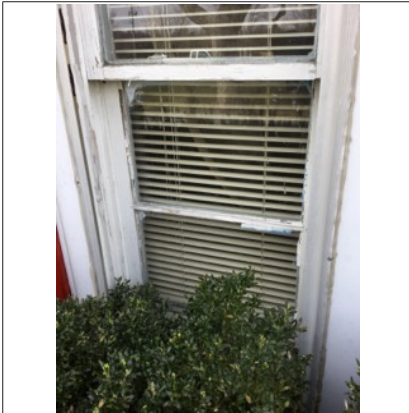
Broken storm window. Old wood window needs repair or replaced

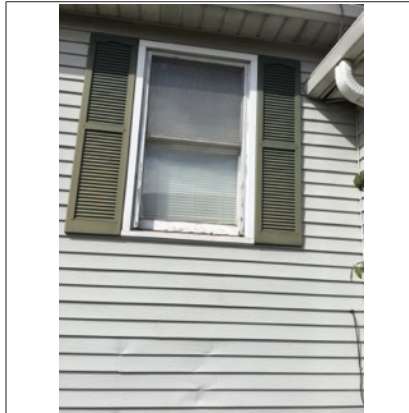
Typical damaged screens

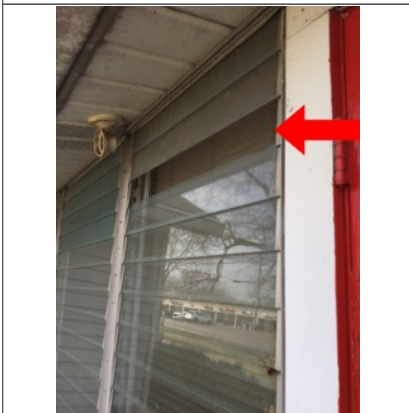
Missing glass

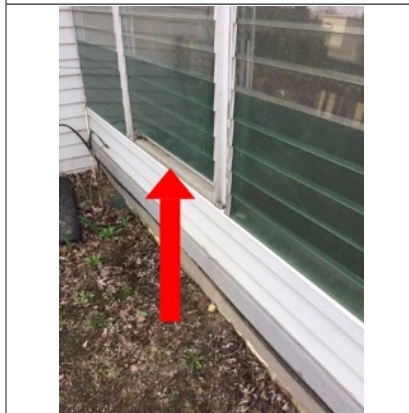
Missing glass

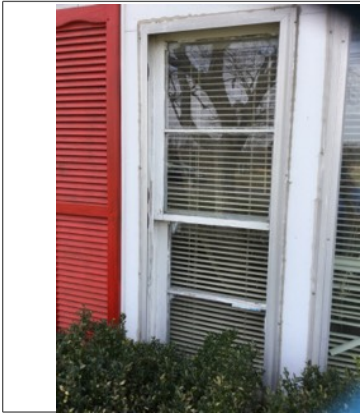
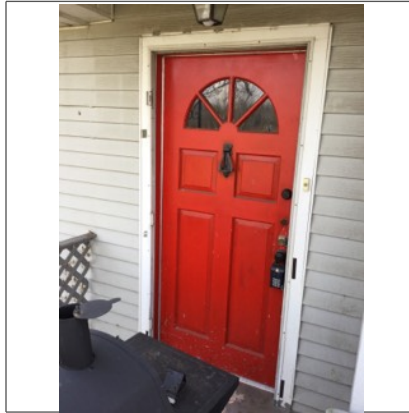
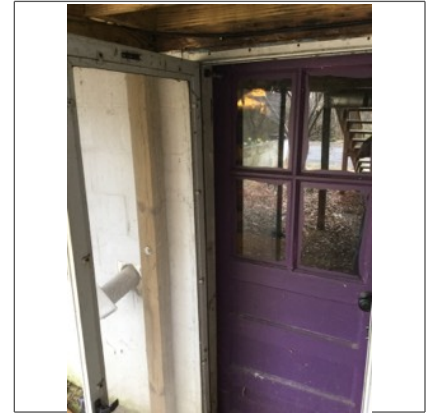
- Condition** Satisfactory Broken/cracked Wood rot Recommend repair/painting
 Missing/damaged Screen Adjustment Needed
- Material** Wood Clad comb. Wood/Metal comb. Metal
- Putty** Satisfactory Needed N/A
- Comments** Front storm door is missing. Rear door needs adjustment storm window in front of home has missing glass.
 Door under deck is missing a closer

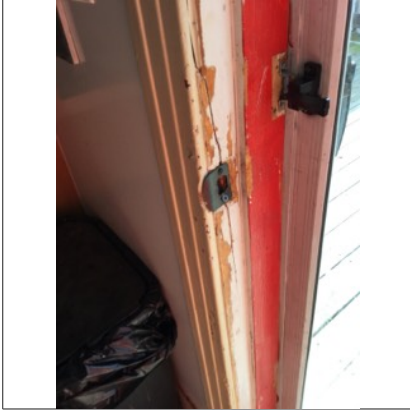
- Main Entrance** N/A Weatherstripping: Satisfactory Marginal **Poor** Missing Replace
 Door condition: **Satisfactory** Marginal Poor
- Patio** N/A Weatherstripping: Satisfactory Marginal Poor Missing Replace
 Door condition: Satisfactory Marginal Poor
- Rear door** N/A Weatherstripping: Satisfactory Marginal **Poor** Missing Replace
 Door condition: **Satisfactory** Marginal Poor
- Other door** N/A Weatherstripping: Satisfactory Marginal **Poor** Missing Replace
 Door condition: Satisfactory **Marginal** Poor
- Comments** Basement door needs repair

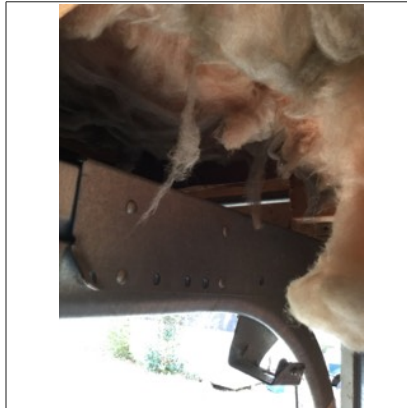
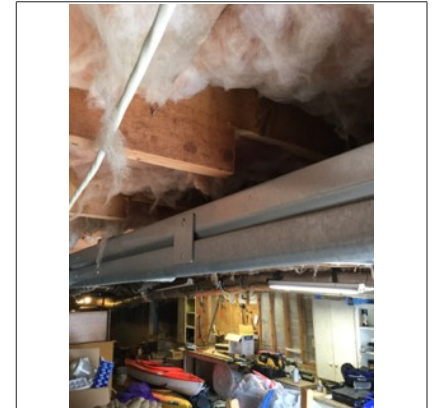
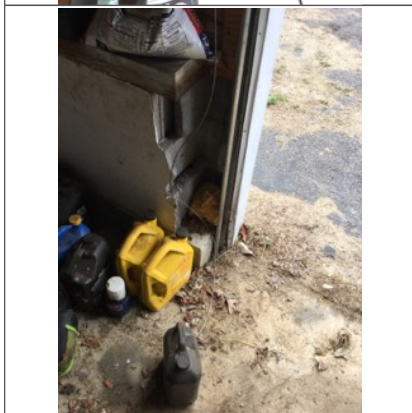
The door has some damage and one person can't open it. It needs repair. A floor joists was modified to install this door. I doubt that is acceptable see photo.

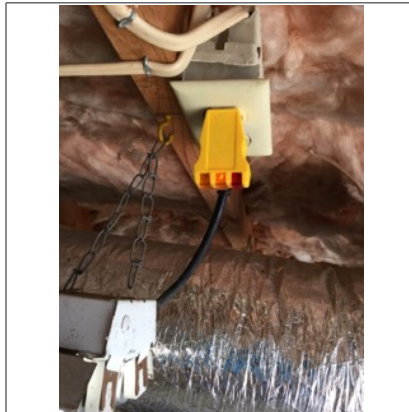
Yes No Not Visible Operable: Yes No
Reverse polarity Yes No
Open ground Yes No Safety Hazard
GFCI Present Yes No Operable: Yes No Handyman/extension cord wiring
 Recommend GFCI Receptacles
Comments Some cover plates missing
Photos

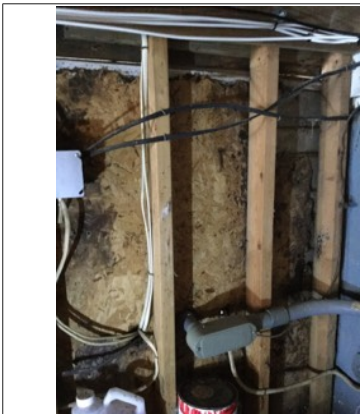
Some moisture stains

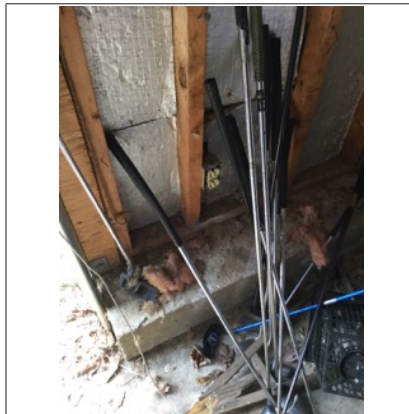
Missing cover plates. Typical

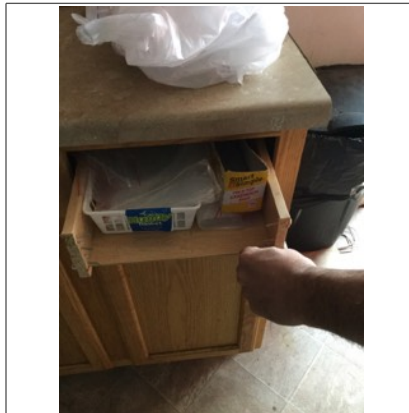
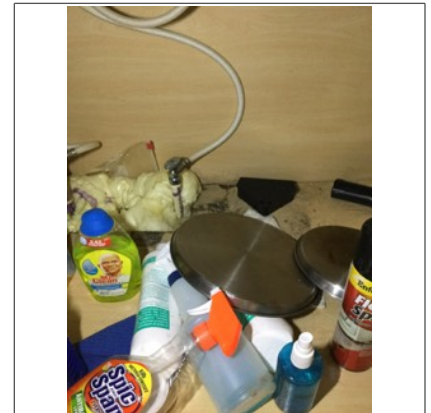
Sink has damage from prior leak. One drawer front broken panel is inside cabinet.

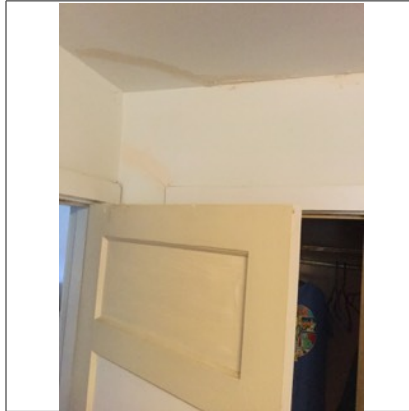
Comments Missing electric plates and settling cracks

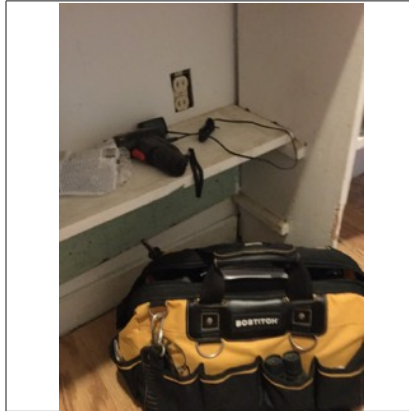
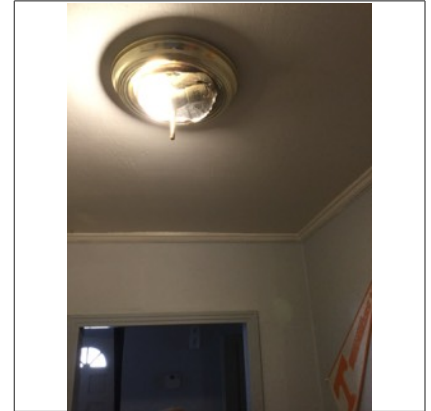
Comments Lights all need covers so bulb is not exposed. . Floor patch needed. Missing cover plates.

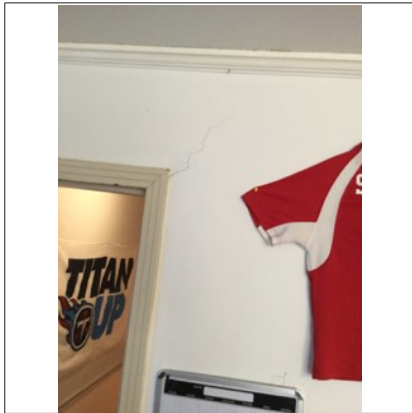
Comments Minor settling cracks. Floor slopes.

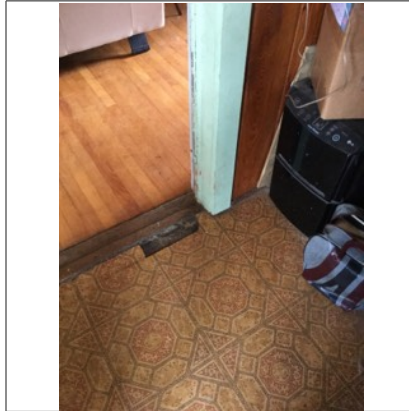
Comments Some missing floor

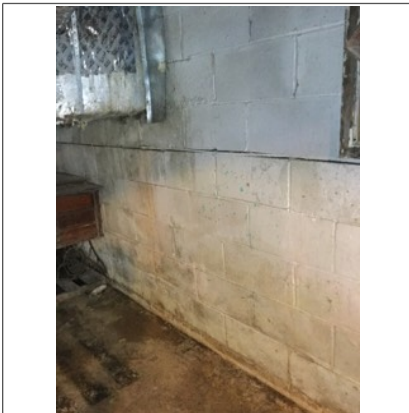
Horizontal crack with moisture stains

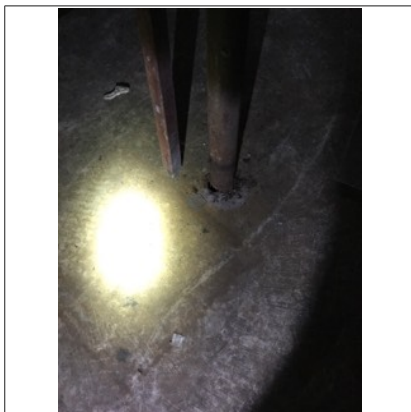
Not Visible
Condition Satisfactory Marginal Poor Stained/Rusted
Material Steel Wood Concrete Block Not Visible
Comments Severe rust and one broken column. At some point these should be replaced
Photos

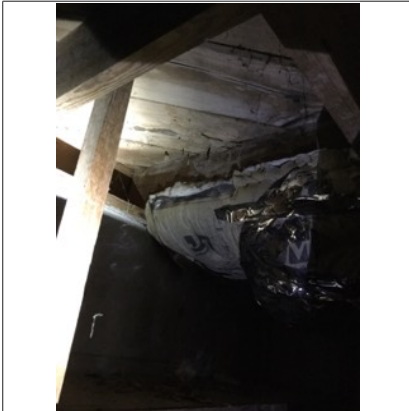
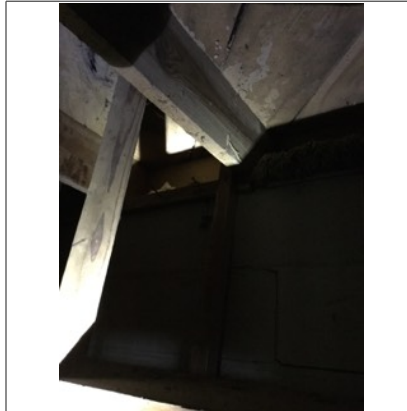
Comments Most floor is not visible. What I saw was planked sub floor and in satisfactory condition with a small area of possible insect damage. Insulation blocks most views

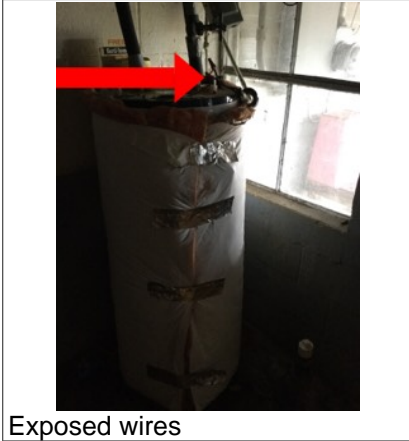
Comments Has an unsafe electrical connection

Exposed wires

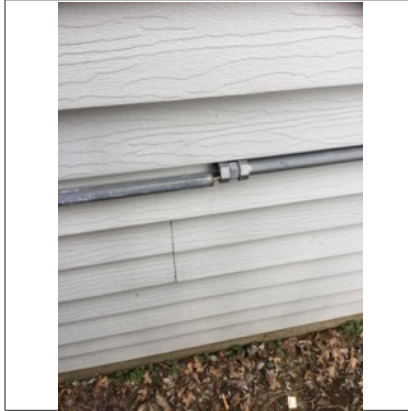
Location Back of house under deck
Condition Satisfactory Poor
Amperage/Voltage Unknown 60a 100a 150a 200a 400a 120v/240v
Adequate Clearance to Panel Yes No
Breakers/Fuses Breakers Fuses
Appears grounded Yes No Not Visible
GFCI breaker Yes No Operable: Yes No
AFCI breaker Yes No Operable: Yes No Not Tested
Main wire Copper Aluminum Not Visible Double tapping of the main wire
 Condition: Satisfactory Marginal Poor
Branch wire Copper Aluminum Solid Branch Aluminum Wiring Not Visible Safety Hazard
Branch wire condition Satisfactory Poor Recommend electrician evaluate/repair Romex BX cable
 Conduit Knob/Tube Double tapping Wires undersized/oversized breaker/fuse
 Panel not accessible Not evaluated
Reason:
 The inside cover plate is missing and needs to be replaced

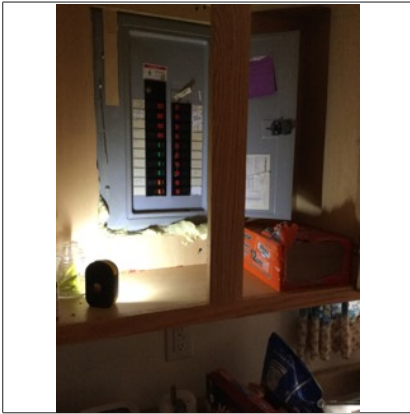
None apparent
Location(s) Location 1:
 Kitchen inside cabinets
 Location 2:
 Location 3:
Evaluation Panel not accessible Not evaluated
Reason:
 Recommend separating/isolating neutrals Recommend electrician repair/evaluate box
Branch wire Copper Aluminum Safety hazard Neutral/ground separated: Yes No
 Neutral isolated: Yes No Not Visible
Condition Satisfactory Marginal Poor Not Visible
Comments The panel is inside a kitchen cabinet so I could not remove the panel
