HOME INSPECTION REPORT

Bear Wallow Rd, Ashland City, TN 37015

Friday, January 9, 2026

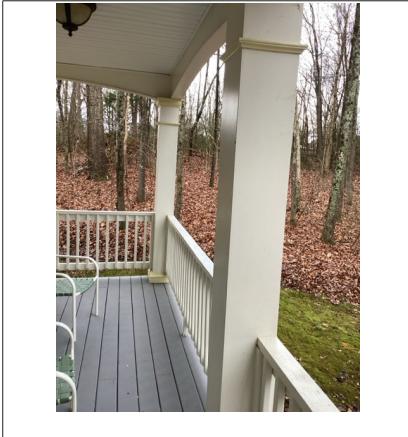
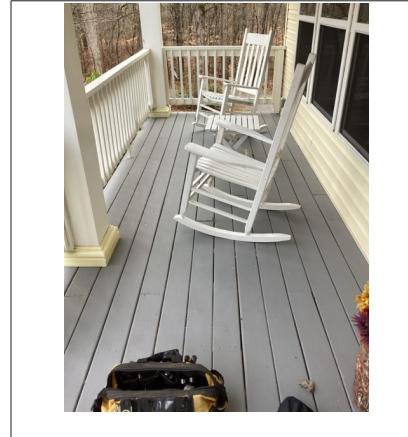
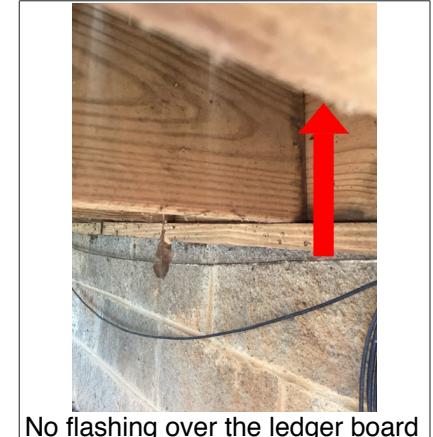
Condition	<input type="checkbox"/> None <input type="checkbox"/> Not Visible <input checked="" type="checkbox"/> Satisfactory <input type="checkbox"/> Marginal <input type="checkbox"/> Poor <input type="checkbox"/> Railing/Balusters recommended <input type="checkbox"/> Repair Needed
Support Pier	<input type="checkbox"/> Concrete <input checked="" type="checkbox"/> Wood <input type="checkbox"/> Composite <input type="checkbox"/> Other <input type="checkbox"/> None
Floor	<input checked="" type="checkbox"/> Satisfactory <input type="checkbox"/> Marginal <input type="checkbox"/> Poor <input type="checkbox"/> Safety Hazard
Comments	Didn't get ceiling lights on No flashing over ledger board

Porch deck did not have flashing over ledger board
Side stairs suggest adding bolts where beams meet posts on all sides
Service door has damaged areas at trim and jamb. Missing flashing over the door
Gutters. Suggest adding gutter guards
Roof moss/ algae growth present. It can shorten the life of shingles if not kept clean. Visible shingle damage
Right side of home has a negative grade. May contribute to damage at garage service door

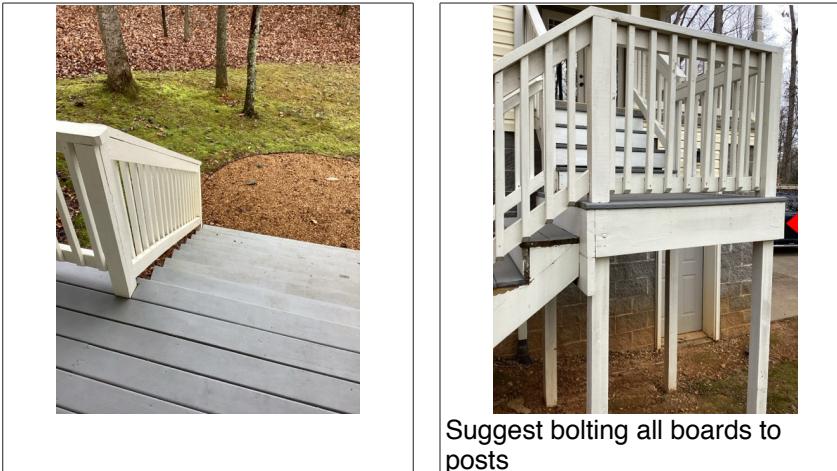
Material Condition	<input type="checkbox"/> None <input type="checkbox"/> Concrete <input checked="" type="checkbox"/> Wood Other: <input checked="" type="checkbox"/> Railing/Balusters recommended <input type="checkbox"/> Brick <input type="checkbox"/> Composite <input checked="" type="checkbox"/> Satisfactory <input type="checkbox"/> Marginal <input type="checkbox"/> Poor <input type="checkbox"/> Safety Hazard <input type="checkbox"/> Uneven risers <input type="checkbox"/> Rotted/Damaged <input type="checkbox"/> Cracked <input type="checkbox"/> Settled <input type="checkbox"/> Repair Recommended
Comments	Suggest adding bolts to all perimeter boards that tie into the posts

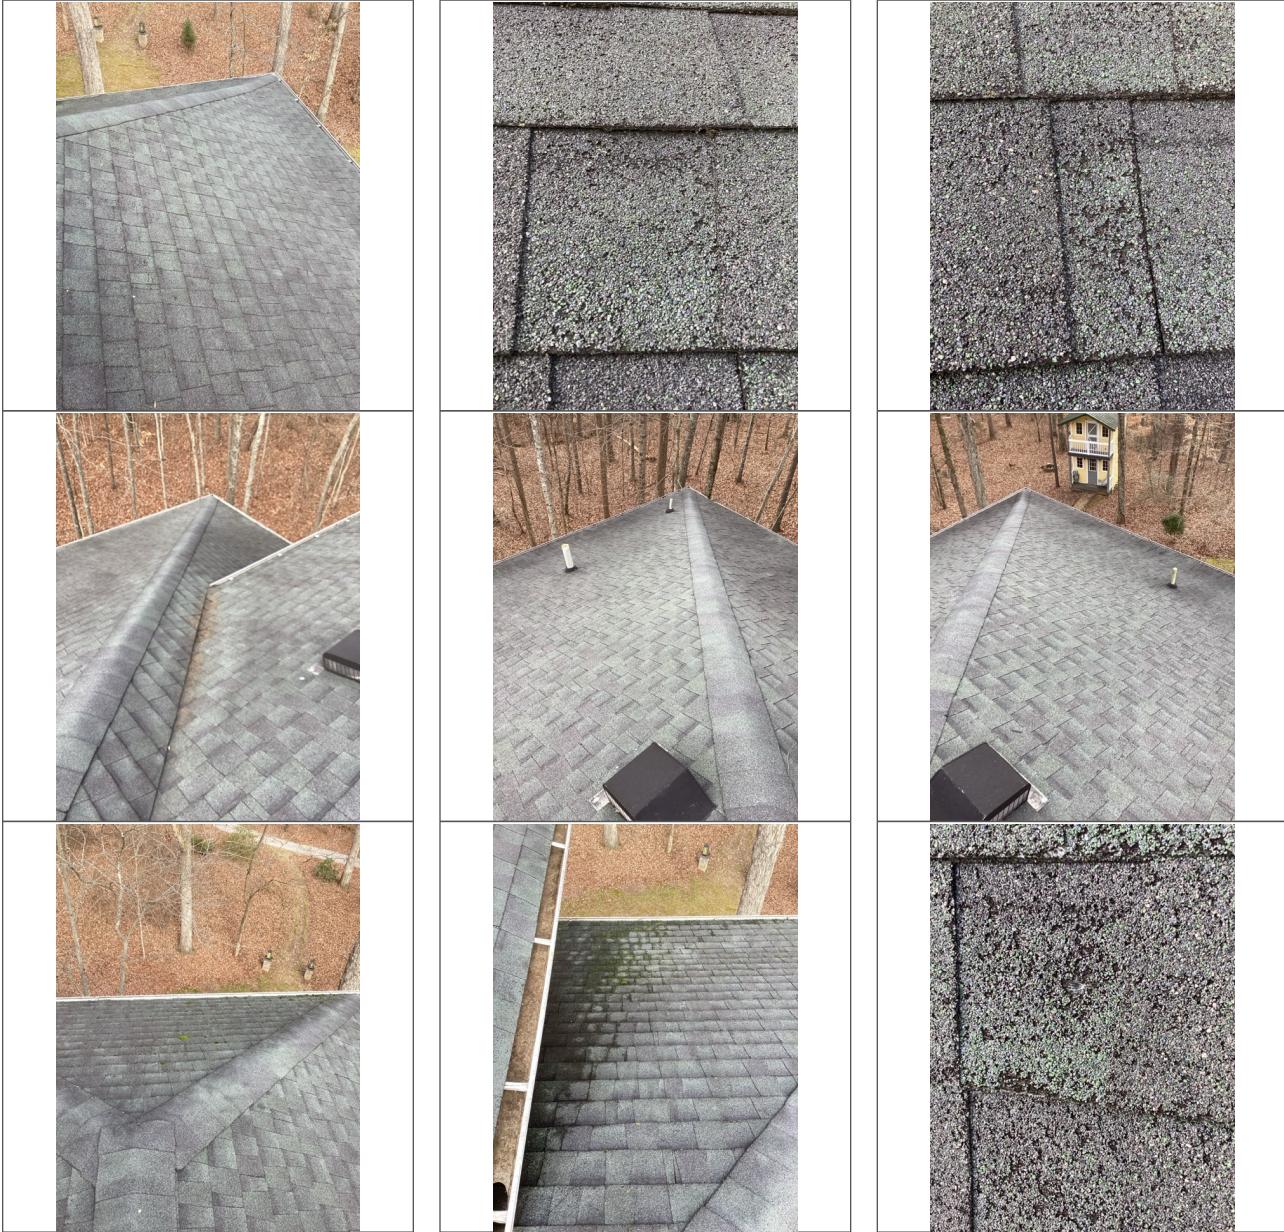
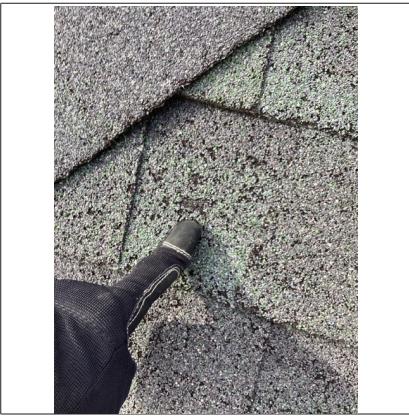
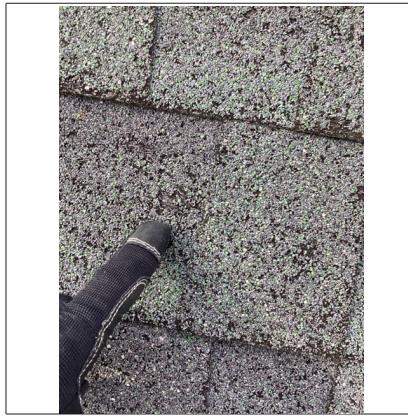
Roof #1 Satisfactory Marginal Poor Curling Cracking Ponding Burn Spots
 Broken/Loose Tiles/Shingles Nail popping Granules missing Alligatoring Blistering
 Missing Tabs/Shingles/Tiles Moss buildup Exposed felt Cupping
 Incomplete/Improper Nailing Recommend roofer evaluate Evidence of Leakage
Roof #2 N/A Satisfactory Marginal Poor Curling Cracking Ponding Burn Spots
 Broken/Loose Tiles/Shingles Nail popping Granules missing Alligatoring Blistering
 Missing Tabs/Shingles/Tiles Moss buildup Exposed felt Cupping
 Incomplete/Improper Nailing Recommend roofer evaluate Evidence of Leakage
Roof #3 N/A Satisfactory Marginal Poor Curling Cracking Ponding Burn Spots
 Broken/Loose Tiles/Shingles Nail popping Granules missing Alligatoring Blistering
 Missing Tabs/Shingles/Tiles Moss buildup Exposed felt Cupping
 Incomplete/Improper Nailing Recommend roofer evaluate Evidence of Leakage
Comments Very heavy pitting. Possible heat damage although hard to fathom that with all the trees

Comments cont. Appears to uniform for typical hail damage. Some definitely could be hail damage but also tree branch damage
I sent photos to a roofer that does a lot of work in the area for his thoughts on cause

The water heater and both HVAC units are original
The roof has some excessive granule loss and possibly some damage from either hail or branches.
Suggest evaluation by roofer to provide idea on longevity and or possibly insurance claim. It's original at about 16-17 years old

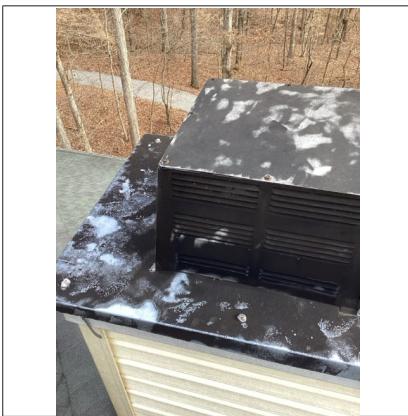
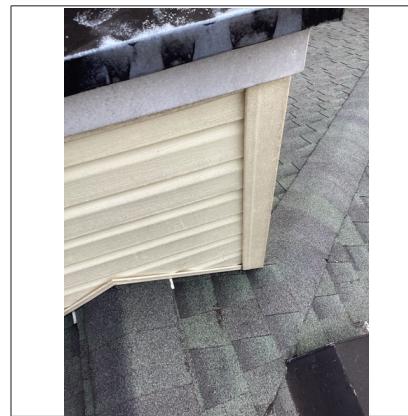
Chimney(s)	<input type="checkbox"/> None
Location(s)	Center of home
Viewed From	<input checked="" type="checkbox"/> Roof <input type="checkbox"/> Ladder at eaves <input type="checkbox"/> Ground (Inspection Limited) <input type="checkbox"/> With Binoculars
Rain Cap/Spark Arrestor	<input checked="" type="checkbox"/> Yes <input type="checkbox"/> No <input type="checkbox"/> Recommended
Chase	<input type="checkbox"/> Brick <input type="checkbox"/> Stone <input type="checkbox"/> Metal <input type="checkbox"/> Blocks <input checked="" type="checkbox"/> Framed
Evidence of	<input type="checkbox"/> Holes in metal <input type="checkbox"/> Cracked chimney cap <input type="checkbox"/> Loose mortar joints <input type="checkbox"/> Flaking <input type="checkbox"/> Loose brick <input type="checkbox"/> Rust <input checked="" type="checkbox"/> No apparent defects
Flue	<input type="checkbox"/> Tile <input checked="" type="checkbox"/> Metal <input type="checkbox"/> Unlined <input type="checkbox"/> Not Visible

Evidence of	<input type="checkbox"/> Scaling <input type="checkbox"/> Cracks <input type="checkbox"/> Creosote <input type="checkbox"/> Not evaluated <input type="checkbox"/> Have flue(s) cleaned and re-evaluated <input type="checkbox"/> Recommend Cricket/Saddle/Flashing <input checked="" type="checkbox"/> No apparent defects
Condition	<input checked="" type="checkbox"/> Satisfactory <input type="checkbox"/> Marginal <input type="checkbox"/> Poor <input type="checkbox"/> Recommend Repair
Comments	
Photos

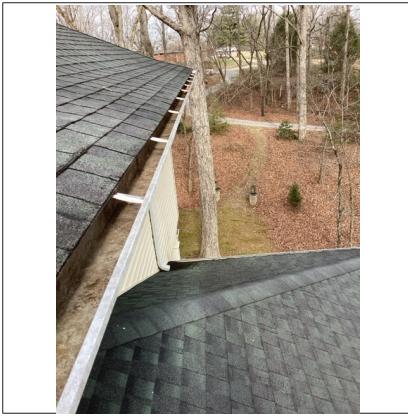
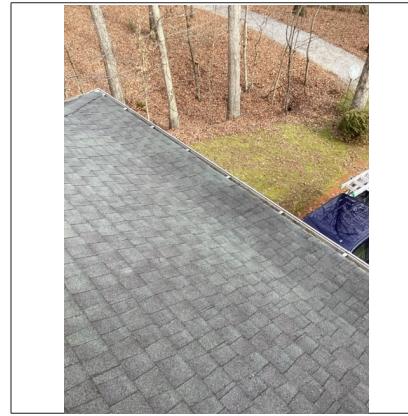
Condition	<input type="checkbox"/> None <input checked="" type="checkbox"/> Satisfactory <input type="checkbox"/> Marginal <input type="checkbox"/> Poor <input type="checkbox"/> Rusting <input type="checkbox"/> Downspouts needed <input type="checkbox"/> Recommend repair/replace
Material	<input type="checkbox"/> Needs to be cleaned <input type="checkbox"/> Add Gutter Guards
Leaking	<input type="checkbox"/> Copper <input type="checkbox"/> Vinyl/Plastic <input checked="" type="checkbox"/> Galvanized/Aluminum Other: _____
Attachment	<input type="checkbox"/> Corners <input type="checkbox"/> Joints <input type="checkbox"/> Hole in main run <input checked="" type="checkbox"/> No apparent leaks
Extension needed	<input type="checkbox"/> Loose <input type="checkbox"/> Missing spikes <input type="checkbox"/> Improperly sloped <input checked="" type="checkbox"/> Satisfactory
Comments	Highly suggest adding gutter guards

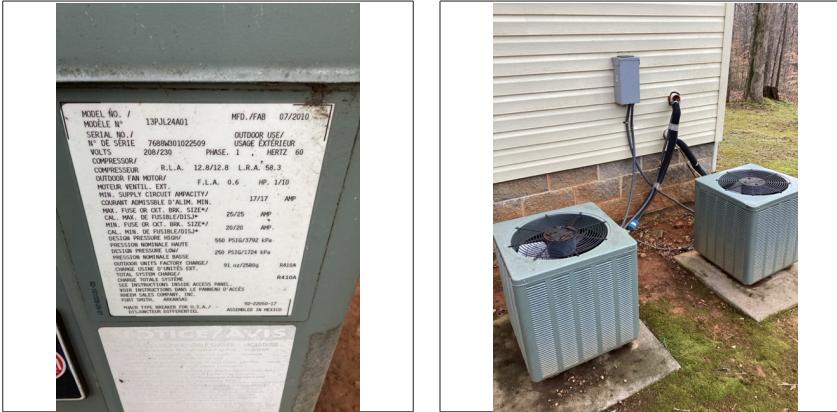
Unit #1 N/A
 Location: Right side of home
 Brand:
 Model #: 13P JL24A01
 Serial #: 7688W301022509
 Approximate Age: 15.5 years
 Condition Satisfactory Marginal Poor Cabinet/housing rusted
 Energy source Electric Gas Other:
 Unit type Air cooled Water cooled Geothermal Heat pump
 Outside Disconnect Yes No Maximum fuse/breaker rating (amps): 25 Fuses/Breakers installed (amps): 25
 Improperly sized fuses/breakers
 Level Yes No Recommend re-level unit
 Condenser Fins Damaged Need cleaning Damaged base/pad Damaged Refrigerant Line Satisfactory
 Insulation Yes No Replace
 Improper Clearance (air flow) Yes No
 Comments

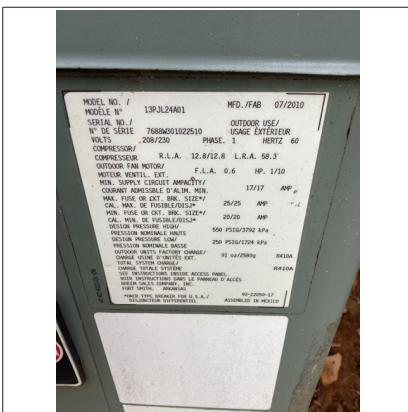
Energy source Electric Gas Other:Unit type Air cooled Water cooled Geothermal Heat pumpOutside Disconnect Yes No Maximum fuse/breaker rating (amps): 25 Fuses/Breakers installed (amps): 25
 Improperly sized fuses/breakersLevel Yes No Recommend re-level unitCondenser Fins Damaged Need cleaning Damaged base/pad Damaged Refrigerant Line SatisfactoryInsulation Yes No ReplaceCondition Satisfactory Marginal Poor Cabinet/housing rustedImproper Clearance (air flow) Yes No

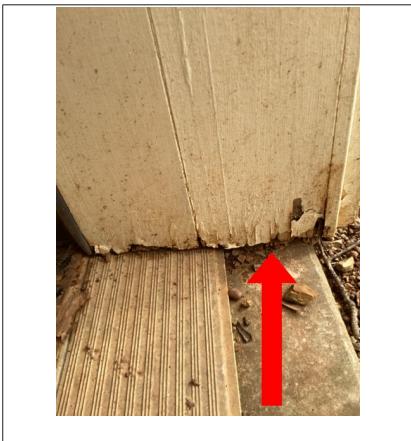
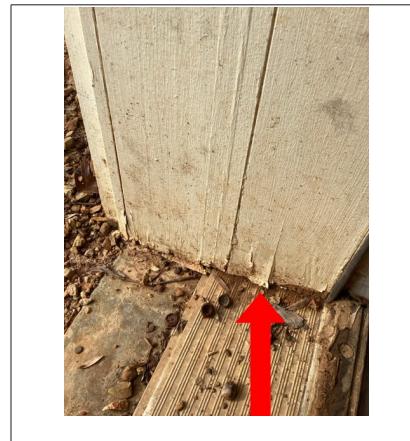
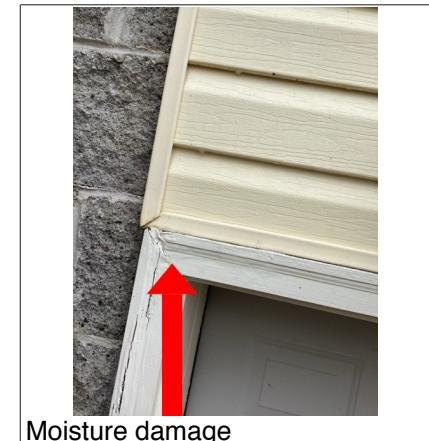
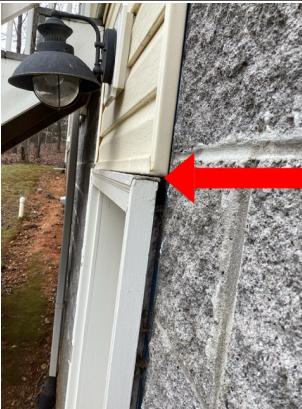
Material N/A Same as house Wood Aluminum Vinyl
Condition Satisfactory Marginal Poor Recommend repair/replace Recommend painting
Comments Some minor damage at bottom of door jamb and trim
The light outside the service door is not working
Can't tell what all switches operate

Flashing is missing allowing water damage

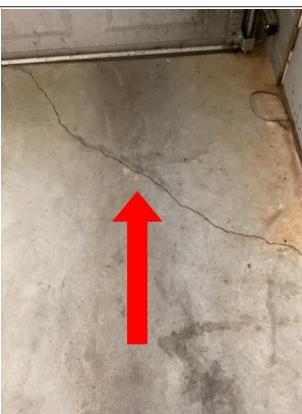
Typical cracks.

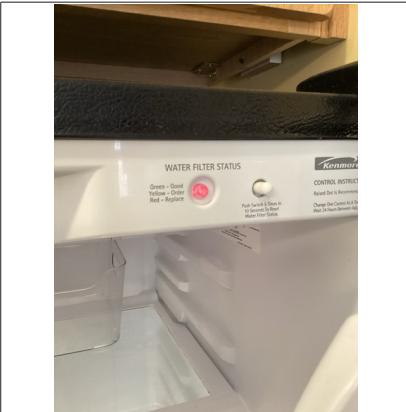
The icemaker was turned off, so no way to check that dispenser, but it appears that it will work based on the sound. The water dispenser works.

Replace refrigerator water filter

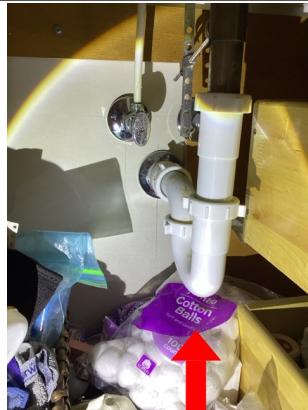
Slowly dripping underneath the drain line of the left sink

There is a minor leak under left sink in upstairs bath. Minimal but left un-repaired could cause damage
Should get roof evaluation
Consider structural evaluation if concerned about minor vertical cracks in foundation wall

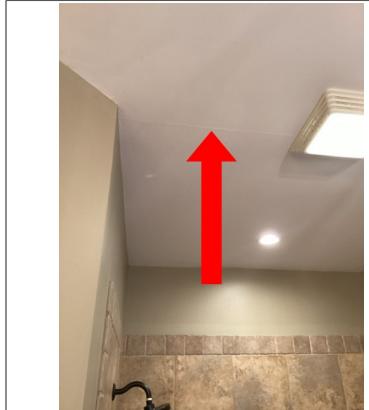
Typical ceiling cracks along the drywall seam

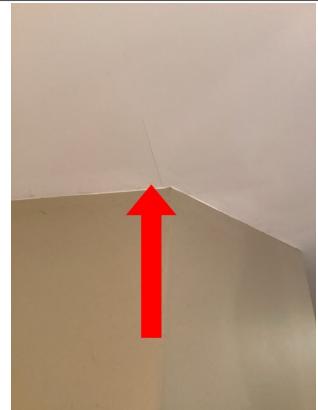
Typical cracks along drywall seams

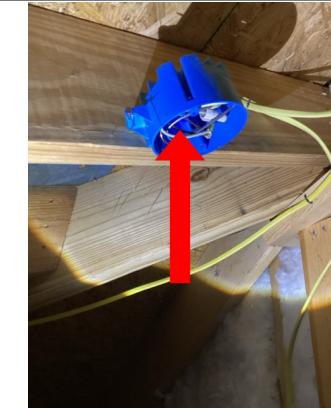
All electric boxes should have a cover plate

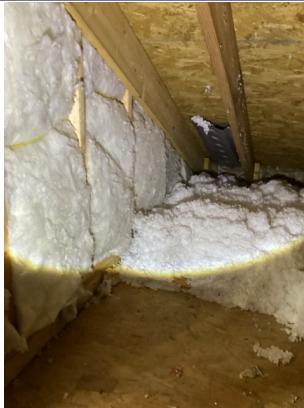
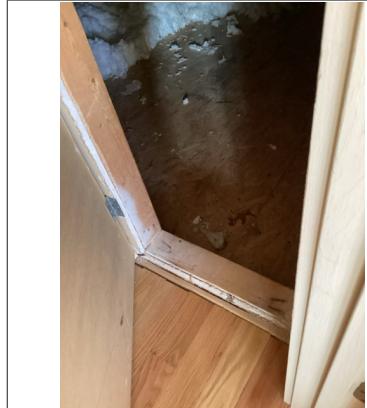
Attic access doors should be sealed for heat/ cooling loss/ gain

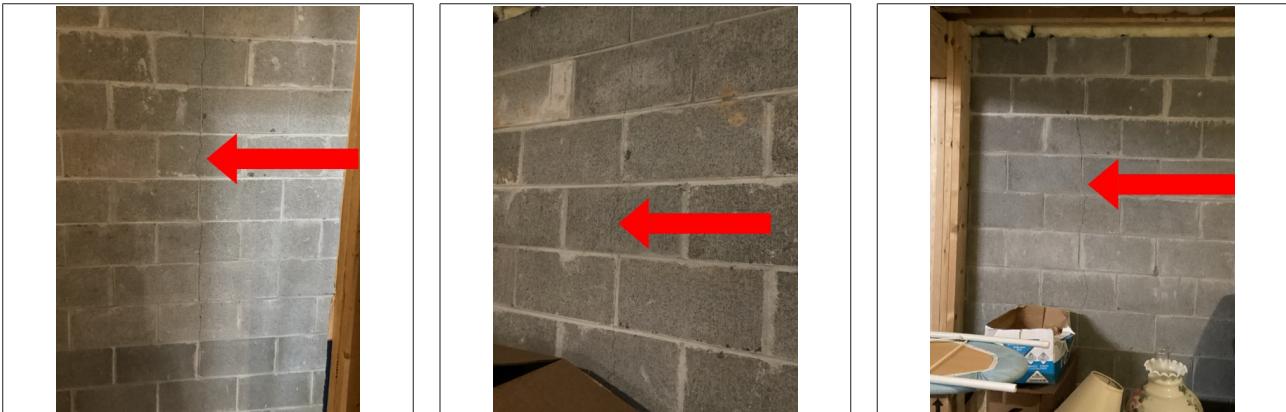
Comments There are three visible vertical cracks in the concrete block floor to ceiling. The gaps are barely a 16th of an inch wide and there is no current displacement. Typical causes can be due to normal drying and shrinkage of both mortar and block and typical minor foundation movement but most often it does not indicate structural failure. I am not a structural engineer so you may want to get a structural viewpoint on this. It appears satisfactory to me based on my experience but you should have it looked at for peace of mind and a professional opinion.

Comments Minor vertical cracks in block foundation. No significant movement noted. I'm not a structural engineer and you should have the vertical cracks evaluated

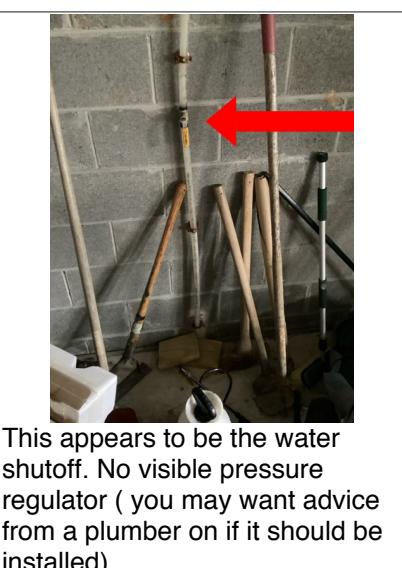
This appears to be the water shutoff. No visible pressure regulator (you may want advice from a plumber on if it should be installed)

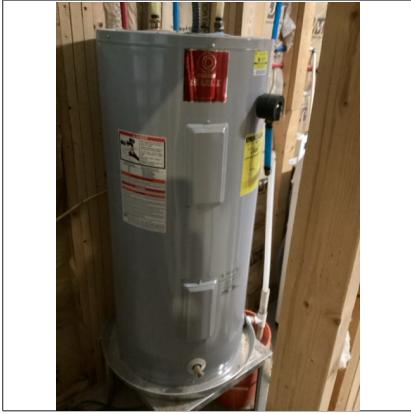
Water heater #1

N/A
General
 Brand Name: State select
 Serial #: 1049A009534
 Capacity: 50 gallons
 Approx. age: 15 years
Type Gas Electric Oil LP Other:
Combustion air venting present Yes No N/A
Seismic restraints needed Yes No N/A
Relief valve Yes No Extension proper: Yes No Missing Recommend repair Improper material
Vent pipe N/A Satisfactory Pitch proper Improper Rusted Recommend repair
Condition Satisfactory Marginal Poor
Comments
Photos

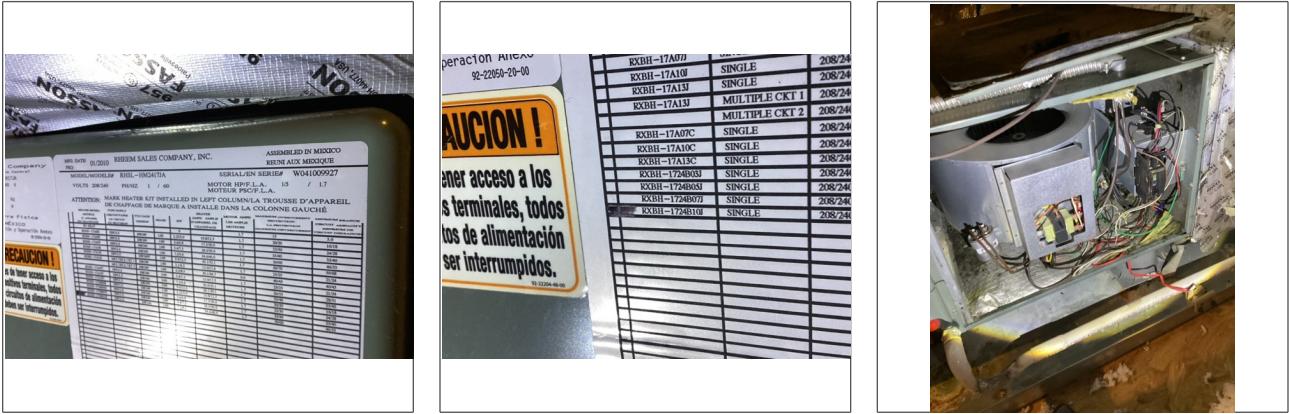
Flue piping N/A Satisfactory Rusted Improper slope Safety hazard Recommend repair/replace
Filter Standard Electrostatic Satisfactory Needs cleaning/replacement Missing
 Electronic (not tested)
When turned on by thermostat Fired Did not fire Proper operation: Yes No Not tested
Heat pump N/A Supplemental electric Supplemental gas
Sub-slab ducts N/A Satisfactory Marginal Poor Water/Sand Observed: Yes No
System not operated due to N/A Exterior temperature Other: .
Comments Always change HVAC filters upon move-in
 Heat kit RXBH-1724B10J

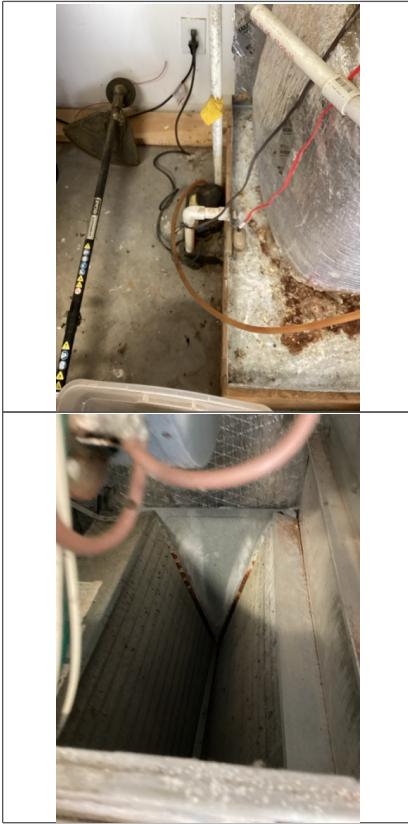
Comments Suggest cleaning at yearly service

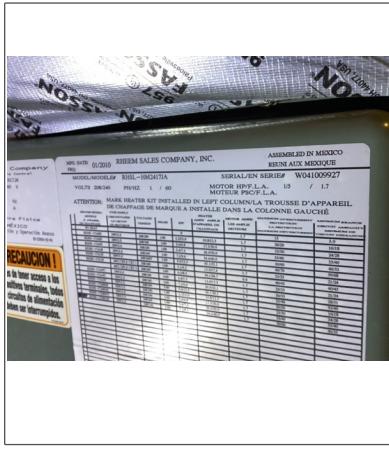
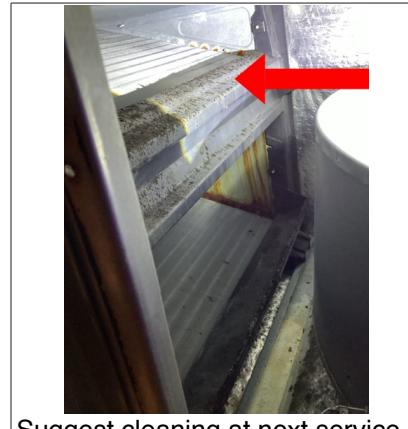
Comments Some rust is evident

Some dirt or possibly microbial growth due to typical summertime moisture when AC is running. Technician should clean during annual service

Suggest cleaning at next service
