HOME INSPECTION REPORT

135 Highway 76, White House, TN 37188

Thursday, February 23, 2017

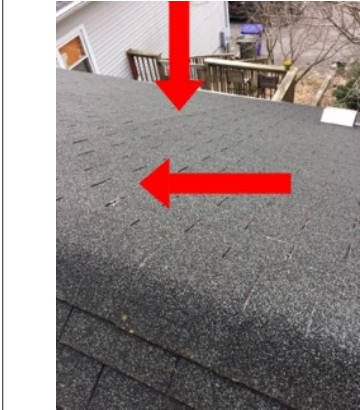
Slight ridge here and a few soft spots. As long as the shingles are ok a little soft spot can be repaired when the roof is redone in the future.

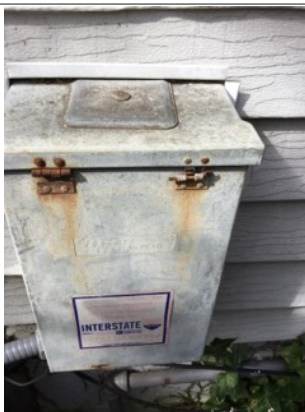
Door hinges are broken on electric breaker box
