HOME INSPECTION REPORT

135 Highway 76, White House, TN 37188

Thursday, February 23, 2017

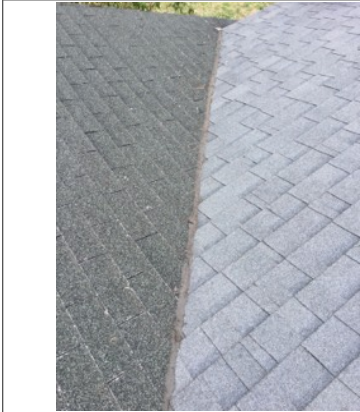
Comments There are 2 different shingles. The addition shingles are in better shape than the main home but both roofs still have life left in them. It's difficult to determine age but I guess the main house at 15-20 and the addition at 10-15. The home disclosure may provide more info.

Two different shingles

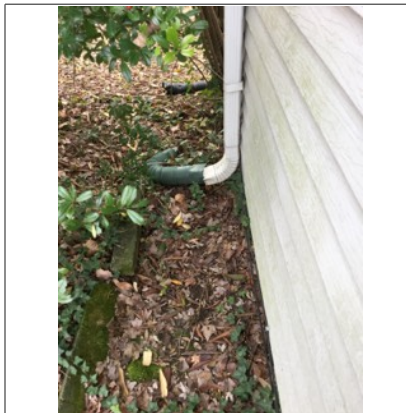
Attach extensions

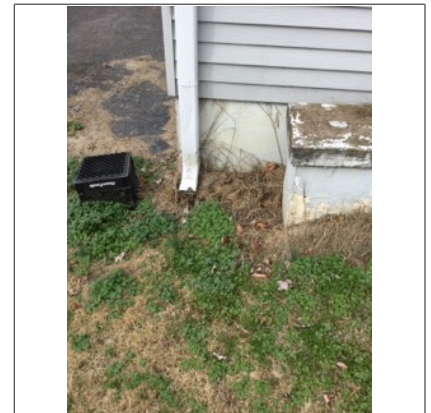
Add extension

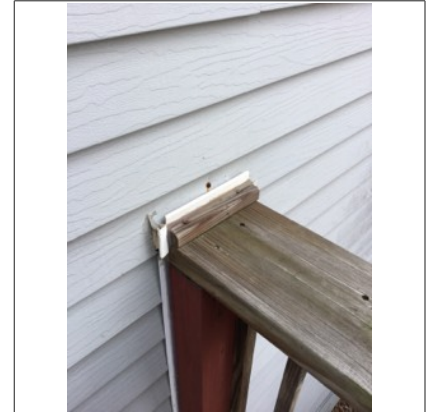
Seal penetrations

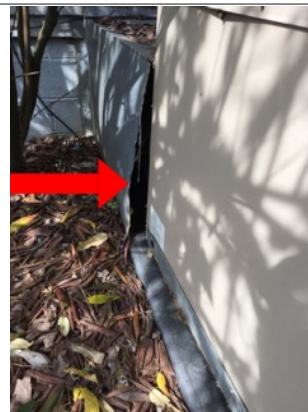
Seal casing

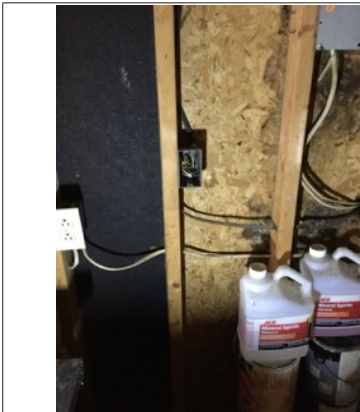
Yes No Not Visible Operable: Yes No
Reverse polarity Yes No
Open ground Yes No Safety Hazard
GFCI Present Yes No Operable: Yes No Handyman/extension cord wiring
 Recommend GFCI Receptacles
Comments Some cover plates missing
Photos

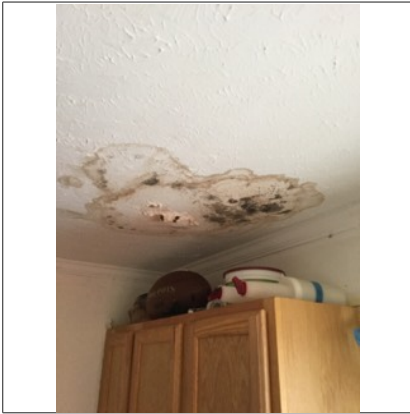
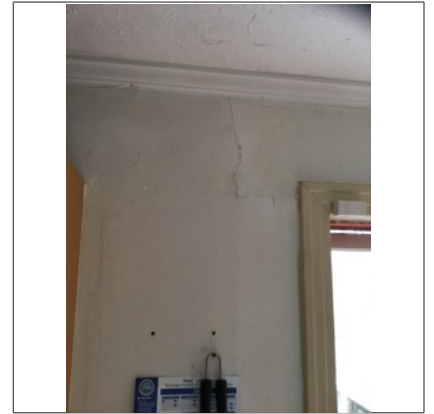
Comments Mold like spores

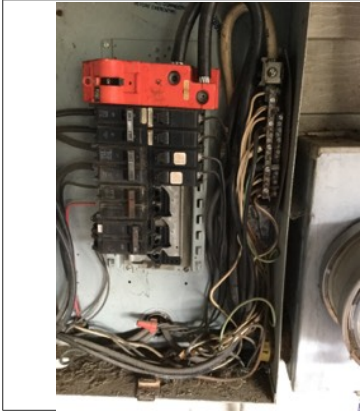
Location Back of house under deck
Condition Satisfactory Poor
Amperage/Voltage Unknown 60a 100a 150a 200a 400a 120v/240v
Adequate Clearance to Panel Yes No
Breakers/Fuses Breakers Fuses
Appears grounded Yes No Not Visible
GFCI breaker Yes No Operable: Yes No
AFCI breaker Yes No Operable: Yes No Not Tested
Main wire Copper Aluminum Not Visible Double tapping of the main wire
 Condition: Satisfactory Marginal Poor
Branch wire Copper Aluminum Solid Branch Aluminum Wiring Not Visible Safety Hazard
Branch wire condition Satisfactory Poor Recommend electrician evaluate/repair Romex BX cable
 Conduit Knob/Tube Double tapping Wires undersized/oversized breaker/fuse
 Panel not accessible Not evaluated
Reason:
 The inside cover plate is missing and needs to be replaced
